# HITACHI INVERTER-DRIVEN MULTI-SPLIT SYSTEM HEAT PUMP AIR CONDITIONERS

## *SET-FREE mini FSVG SERIES*

### SERVICE MANUAL

<Outdoor Units>  
RAS-3FSVG  
RAS-4FSVG  
RAS-5FSVG

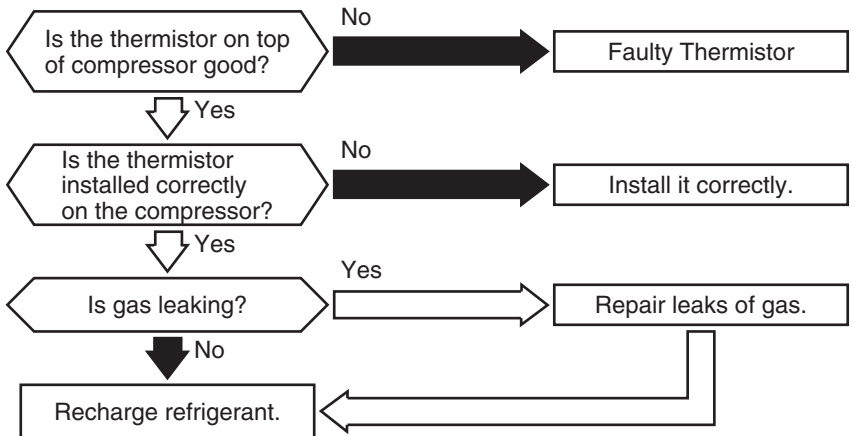
Alarm Code <span style="font-size: 2em; font-family: monospace;">00</span>	<b>Excessively High Discharge Gas Temperature at the Top of Compressor Chamber</b>
--	--

- “RUN” light flashes and “ALARM” is indicated on the remote control switch.
  - The unit No., alarm code and the unit code is alternately indicated on the set temperature section, and the alarm code is indicated on the display of the outdoor unit PCB.
- ★ This alarm is indicated when the following conditions occurs three times within one hour;  
The temperature of the thermistor on the top of the compressor is maintained higher than 132°C for 10 minutes, or the temperature of the thermistor on the top of the compressor is maintained higher than 140°C for 5 seconds.

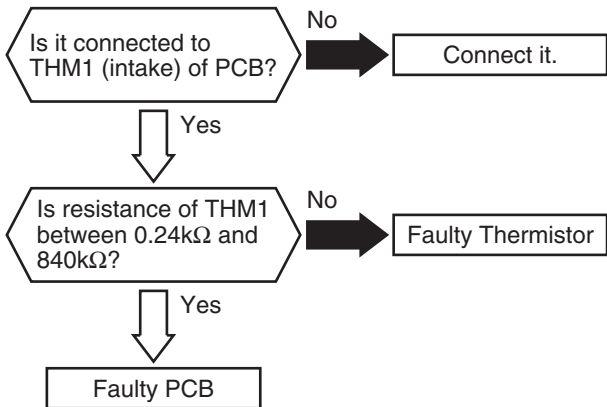
Alarm Code	11	<b>Abnormality of Thermistor for Indoor Unit Inlet Air Temperature (Air Inlet Thermistor)</b>
------------	----	---

- “RUN” light flashes and “ALARM” is indicated on the remote control switch.
  - The unit No., alarm code and the unit code is alternately indicated on the set temperature section, and the alarm code is indicated on the display of the outdoor unit PCB.
- ★ This alarm code is indicated when the thermistor is short-circuited (less than 0.24 kΩ) or cut (greater than 840 kΩ) during the cooling or heating operation. The system is automatically restarted when the fault is removed.

Phenomenon	Cause	Check Item	Action (Turn OFF Main Switch)
Faulty Intake Air Thermistor	Fault	Check resistance.	Replace thermistor if faulty.
	Incorrect Connection	Check connection.	Repair wiring and connections.
Faulty PCB		Replace PCB and check operation.	Replace PCB if faulty.

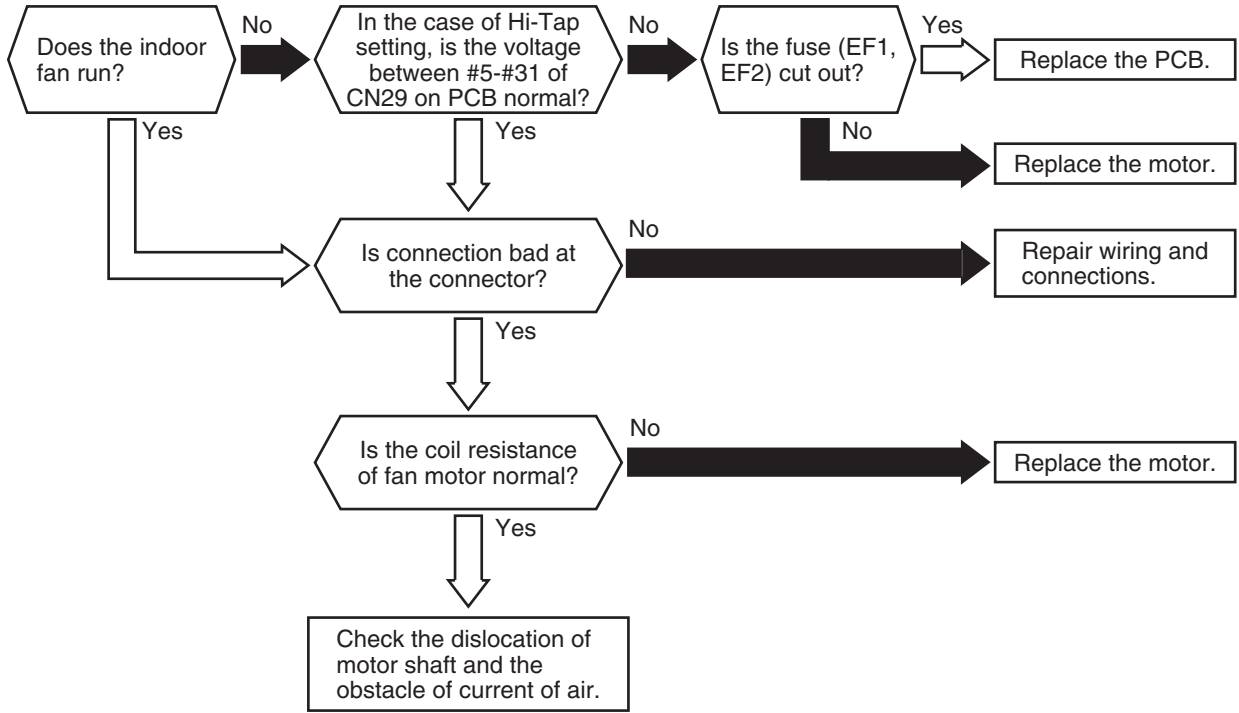
Alarm Code <b>19</b>	<b>Activation of Protection Device for Indoor Fan Motor (RPK-Model)</b>
----------------------	---

- “RUN” light flashes and “ALARM” is indicated on the remote control switch.
  - The unit No., alarm code and the unit code is alternately indicated on the set temperature section, and the unit No. and alarm code are indicated on the display of the outdoor unit PCB.
- ★ This alarm code is indicated when the running current of the indoor fan motor is higher than 1A.

Phenomenon	Cause	Check Item	Action (Turn OFF Main Switch)	
Activation of Overcurrent Protection Device for Indoor Fan Motor	Faulty Indoor Unit Fan Motor	Measure coil resistance and insulation resistance.	Replace motor if faulty.	
	Faulty PCB	Fault	Check the output voltage and fuse in the case of Hi-Tap Setting.	
		Insufficient Contacting	Measure resistance by tester.	Correct looseness. Replace connectors.
		Incorrect Connection	Check connections.	Repair connections.

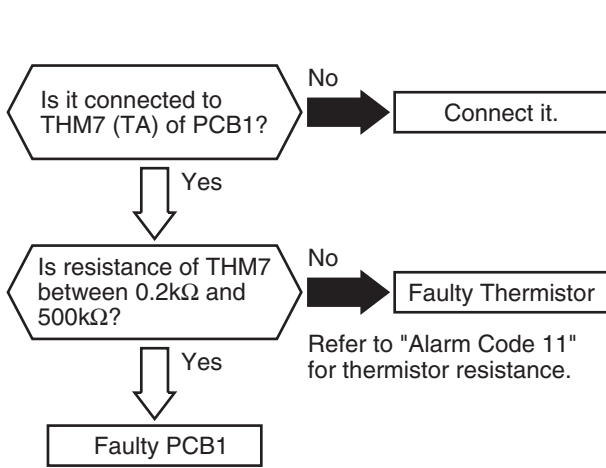
- "RUN" light flashes and "ALARM" is indicated on the remote control switch.
- The unit No., alarm code and the unit code is alternately indicated on the set temperature section, and the alarm code is indicated on the display of the outdoor unit PCB.
- ★ This alarm code is indicated when the thermistor is short-circuited (less than 0.2 kΩ) or cut (greater than 500 kΩ) during running. However, this alarm occurs during test running mode only. In the case that the thermistor is abnormal during running, operation continues based on the assumption that the outdoor temperature, is 35°C (Cooling) / 6°C (Heating).

Phenomenon	Cause	Check Item	Action (Turn OFF Main Switch)
Faulty Thermistor for Outdoor Unit Ambient	Fault	Check resistance.	Replace thermistor if faulty.
	Incorrect Connection	Check wiring to PCB1.	Repair wiring and connections.
Faulty PCB1		Replace PCB1 and check operation.	Replace PCB1 if faulty.

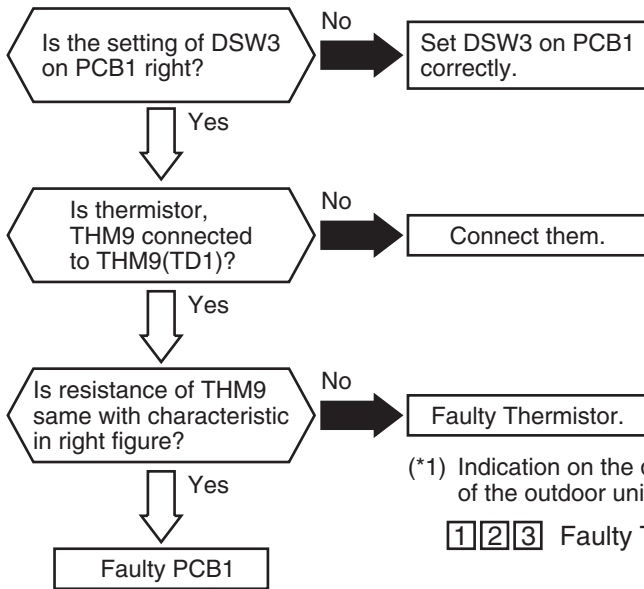
- "RUN" light flashes and "ALARM" is indicated on the remote control switch.
- The unit No., alarm code and the unit code is alternately indicated on the set temperature section, or the unit No. and alarm code are indicated on the display of the outdoor unit PCB. (\*1)  
If abnormality with the thermistor is found, check all the thermistors as shown below.

★ This alarm code is indicated when the thermistor is short-circuited (less than 0.9 kΩ) or cut (greater than 2,350 kΩ) during running.

Phenomenon	Cause	Check Item	Action (Turn OFF Main Switch)
Faulty Discharge Gas Thermistor	Fault	Check resistance.	Replace thermistor if faulty.
	Incorrect Connection	Check wiring to PCB.	Repair wiring and connections.
Faulty PCB		Replace PCB and check operation.	Replace PCB if faulty.
Incorrect Setting of DSW3 on PCB1		Check setting of DSW3 on PCB1.	Correctly set DSW3 on PCB1.

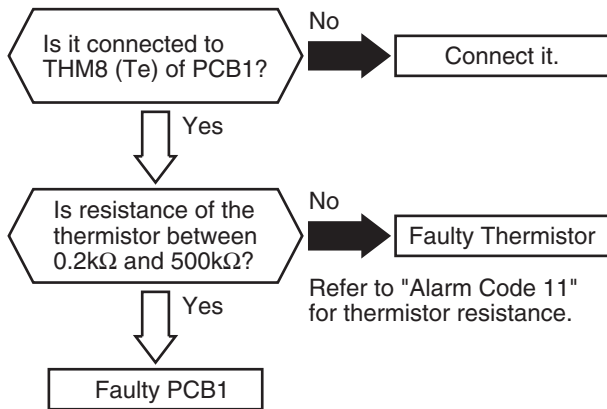
- “RUN” light flashes and “ALARM” is indicated on the remote control switch.
- The unit No., alarm code and the unit code is alternately indicated on the set temperature section, and the alarm code is indicated on the display of the outdoor unit PCB.  
If abnormality with the thermistor is found, check all the thermistors as shown below.

★ This alarm code is indicated when the thermistor is short-circuited (less than 0.2 kΩ) or cut (greater than 500 kΩ) during operation.  
The evaporating thermistor during the heating operation is attached to the heat exchanger as shown below figure.

Phenomenon	Cause	Check Item	Action (Turn OFF Main Switch)
Faulty Thermistor for Evaporating Temperature during Heating	Fault	Check resistance.	Replace thermistor if faulty.
	Incorrect Connection	Check wiring to PCB1.	Repair wiring and connections.
Faulty PCB1		Replace PCB1 and check operation.	Replace PCB1 if faulty.

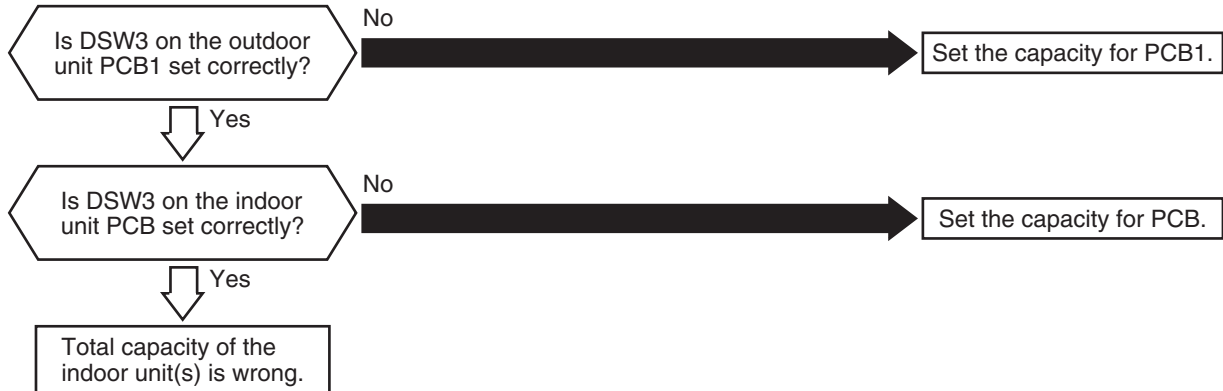
- ★ This alarm code is indicated when the capacity setting dip switch, DSW3 on the outdoor unit PCB1, is not set (all the settings from #1 to #3 are OFF) or mis setting.
- ★ This alarm code is indicated when the total indoor unit capacity is smaller than 50% or greater than 150% of the combined outdoor unit capacity.

Phenomenon	Cause	Check Item	Action (Turn OFF Main Switch)
Incorrect Capacity Setting of Indoor Unit	Incorrect Capacity Setting of Outdoor Unit	Check combination of indoor units and capacity setting on PCB.	Correctly set dip switch, DSW3.
Incorrect Capacity Setting of Outdoor Unit	Total Indoor Unit Capacity Connected to the Outdoor Unit is Beyond Permissible Range	Check capacity setting on outdoor unit PCB.	Correctly set dip switch, DSW3.
Total Indoor Unit Capacity Connected to the Outdoor Unit is Beyond Permissible Range	Refrigeration Cycle Setting of Outdoor Unit and Indoor Unit is Different	Check outdoor unit model by calculating total indoor units capacity.	Ensure that total indoor unit capacity is from 50% to 130%.
Refrigeration Cycle Setting of Outdoor Unit and Indoor Unit is Different		Check refrigeration cycle setting on outdoor unit PCB and indoor unit PCB.	Set them correctly.

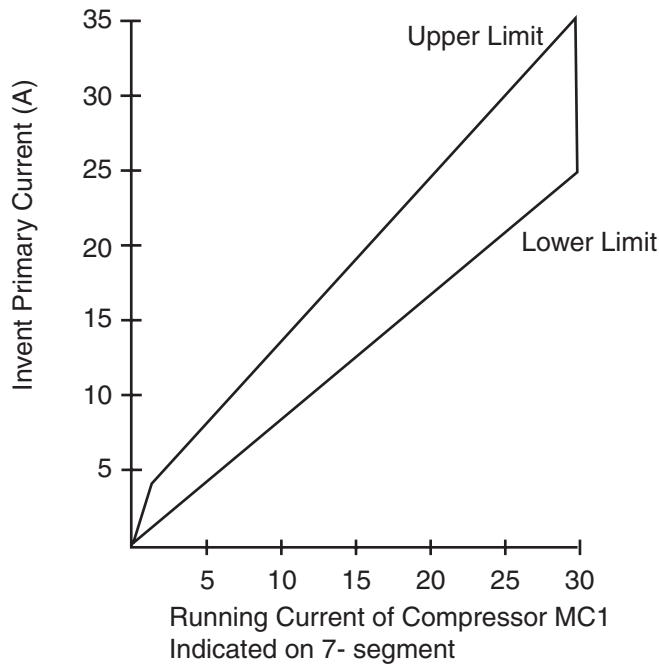
The inverter primary current is estimated from the running current of the compressor MC1 indicated on 7-segments, as chart below.

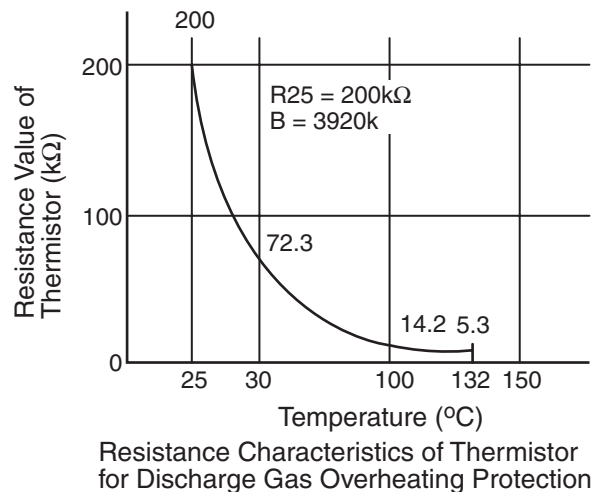
##### (2) Thermistor for Upper Part Temperature of Compressor (For Prevention of Discharge Gas Overheating)

- An electronic expansion valve of indoor units and high pressure refrigerant is returned to the accumulator, decreasing compressor temperature.
- If the compressor upper part temperature increases exceeding 132°C even if an electronic expansion valve opens, the compressor is stopped, in order to protect the compressor. In cooling operation, the above function is also available.
